Name Of Dam: HIDDEN VALLEY LAKE

Location: WASHINGTON COUNTY

Inventory Number: VA 19104 ✓

PHASE I INSPECTION REPORT NATIONAL DAM SAFETY PROGRAM

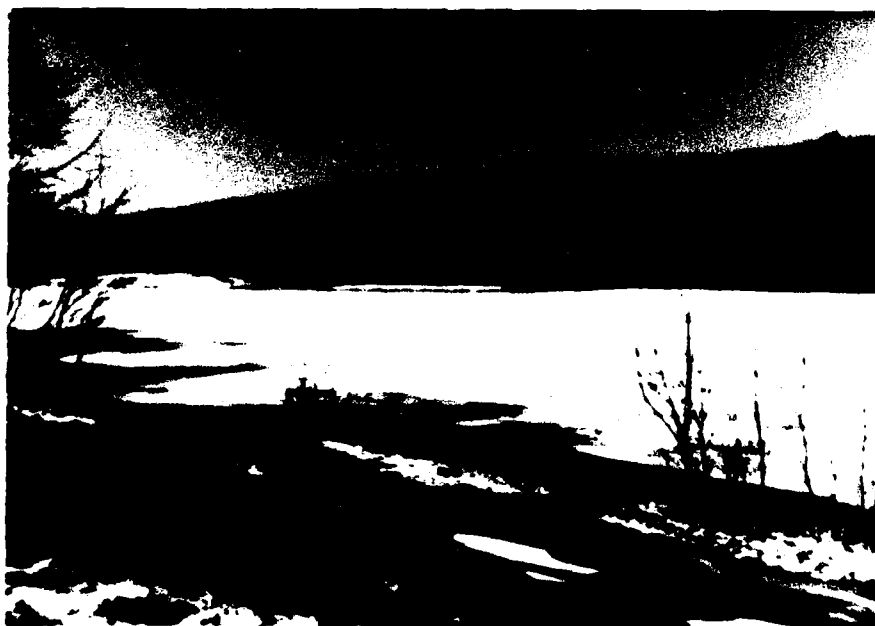
RESERVOIR AREA

3.1.6 Reservoir Area: The reservoir slopes are mild to steep and heavily wooded. The watershed has no development or cleared areas. The lake is covered with a thick layer of ice, except around the shoreline. There is no evidence of shoreline erosion or reservoir slope failure. The inspection team was unable to evaluate the sedimentation condition. An overall view of the reservoir area is provided at the beginning of the report.

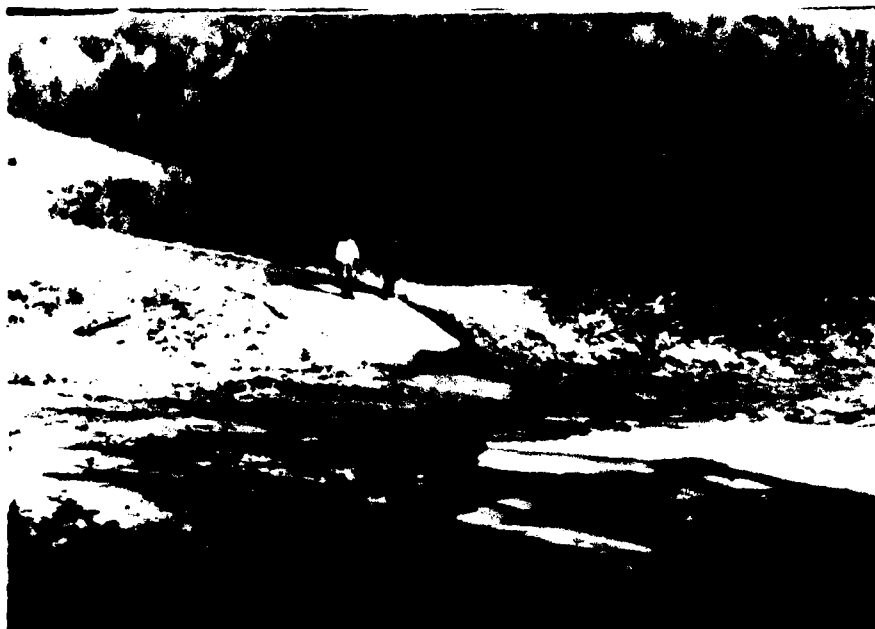
PHOTO #9 EMERGENCY SPILLWAY
(EMS) AND CONTACT
LT. ABUTMENT

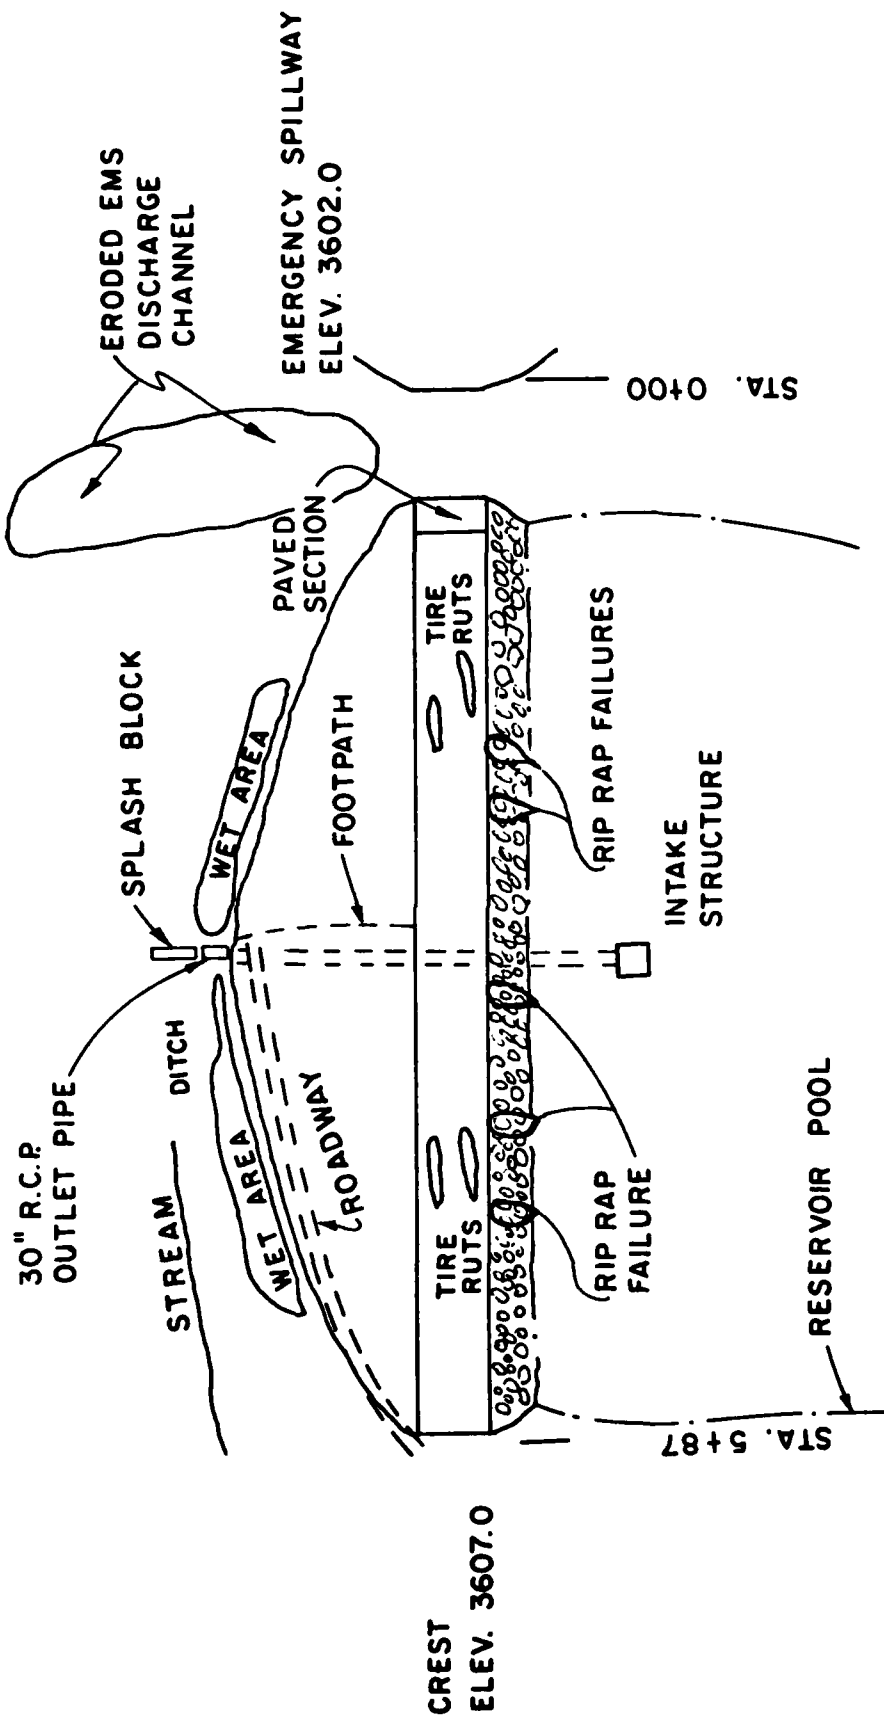
PLAN VIEW OF THE DAM

3.1.2 Embankment: The embankment is in fair condition. A sketch showing a plan view at the time of inspection is included at the back of the checklist in Appendix III. Available design drawings are also included in Appendix I. An overall view of the dam is provided at the beginning of the report.
